Manhole Inspection Summary

Manhole # S27CC_047MH

Insp Date: **4/21/09 3:16 PM**

Location Address: **618 LANVALE ST**

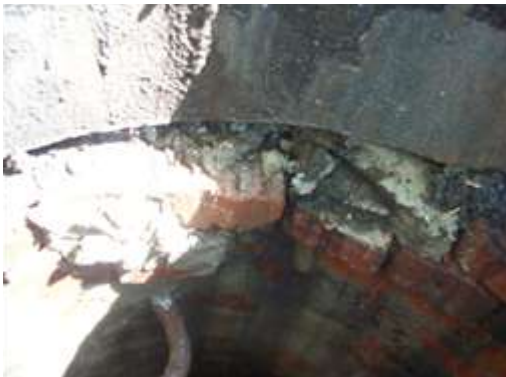
Defect 1

Condition: ☐ Sound ☒ **Cracked** ☐ Root Intrusion ☐ Loose Brick ☐ Deteriorated

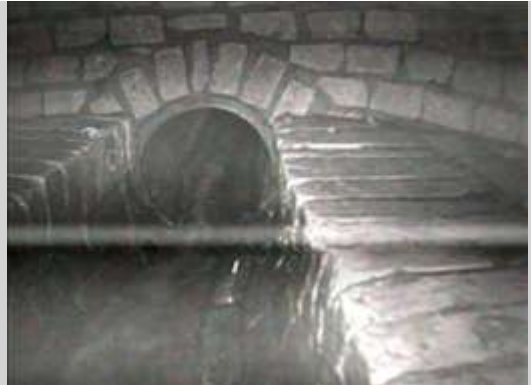
12 O'Clock Outflow

10 in. Circular Gravity Sewer
Pipe Out @ 12 O'Clock

Pipe Height: (in.) Direct
Pipe Material: **Clay** ☐ Pipe Lined
Invert Depth: **13.54** (ft.) Flow Characteristics: **Slow**
Deposits: ☒ None ☐ Mud ☐ Sludge ☐ Debris ☐ Grease
Silt Depth: (in.) Deposits Extent:
Infiltration: **None** Pipe Seal Cond: **Sound**

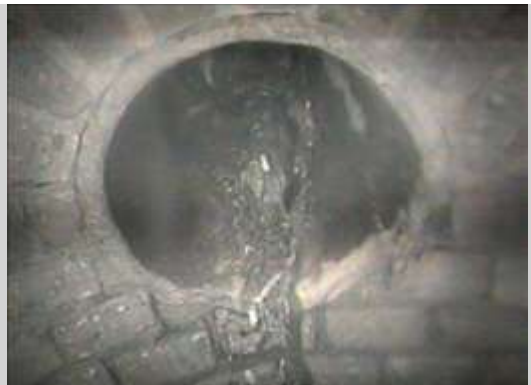
6 O'Clock Inflow

10 in. Circular Gravity Sewer
Pipe In @ 6 O'Clock

Pipe Height: (in.) Direct
Pipe Material: **Clay** ☐ Pipe Lined
Invert Depth: **13.52** (ft.) Flow Characteristics: **Slow**
Deposits: ☒ None ☐ Mud ☐ Sludge ☐ Debris ☐ Grease
Silt Depth: (in.) Deposits Extent:
Infiltration: **None** Pipe Seal Cond: **Sound**

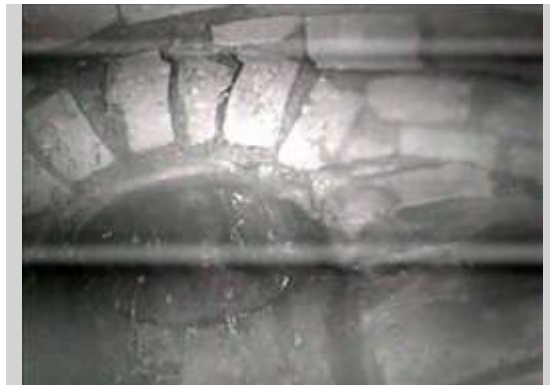
Drop In @ 6 O'Clock

Drop: **Outside Direct**
Angled: Reading: (ft.)
Inv Depth: **13.59** (ft.)

Drop Condition: **Open**
